AN EXPERIMENTAL INVESTIGATION OF HOLLOW TURBINE BLADES

FOR EXPENDABLE JET ENGINES

By W. C. Morgan and C. R. Morse

RESEARCH MEMORANDUMAN EXPERIMENTAL INVESTIGATION OF HOLLOW TURBINE BLADES FOR  
EXPENDABLE JET ENGINES

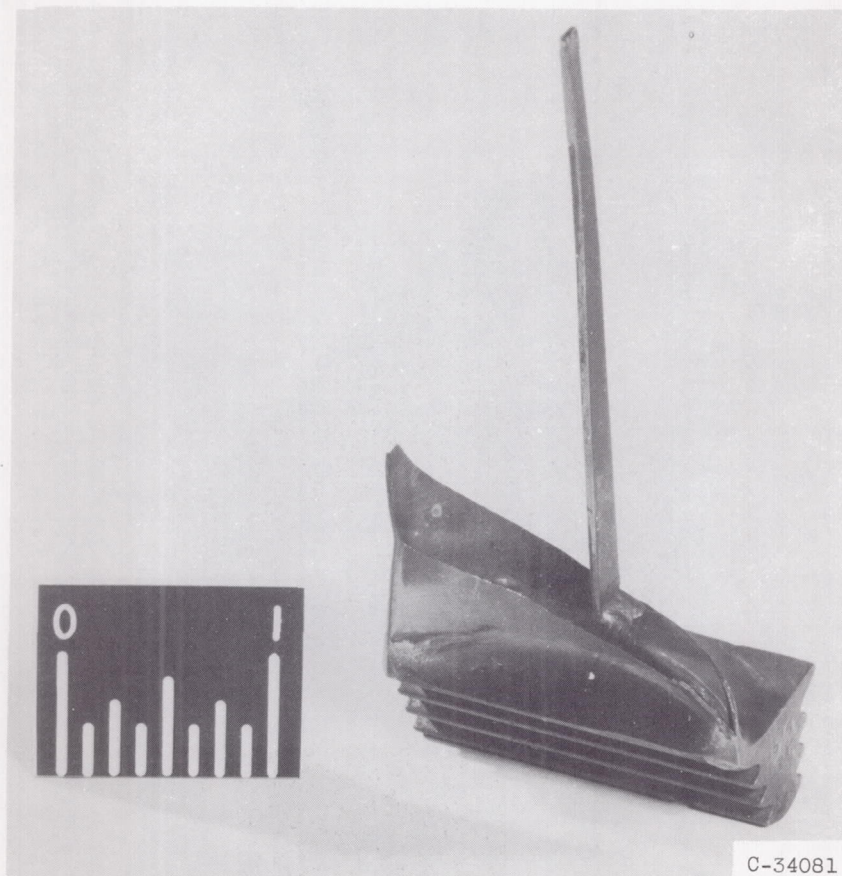
Tests of N-155 and Inconel X. - The initial engine operation of N-155 blades with wall thickness of 0.020 inch was terminated by a blade failure after 23 minutes at rated speed and temperature. The failure originated in the trailing edge at the welded juncture between airfoil and base, as shown in figure 2.

There were fatigue cracks at the tips of the other blades of 0.020-inch wall thickness, and in the subsequent N-155 test blades, the wall thickness was made 0.030 inch. These blades withstood operation for 6 minutes. Failure was attributable to weld failure at the base.

Figure 2. - Failure of N-155 airfoil (0.020-in. wall thickness).

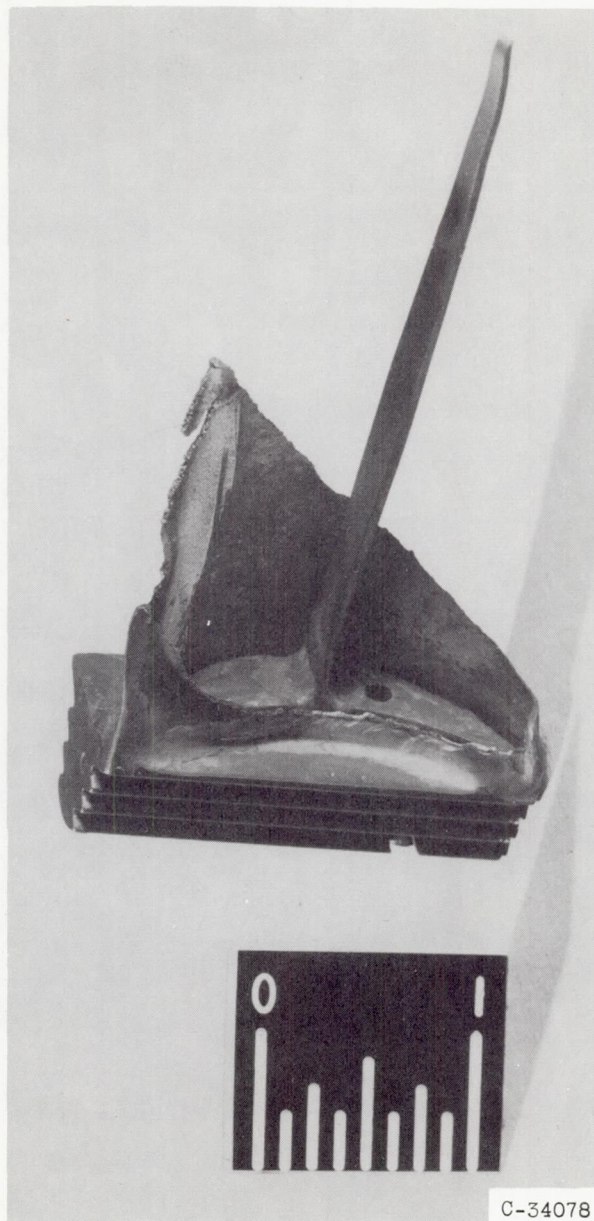
(a) 0.030-Inch wall thickness

Service-operation history was similar in the case of the blades formed from Inconel X. A blade with 0.030-inch wall thickness failed after 31 minutes (fig. 3(a)); another blade formed from material of 0.040-inch thickness was destroyed after 1 hour and 31 minutes (fig. 3(b)). An attempt to alleviate stress failure by the use of tapered stock was unsuccessful; failure occurred after 1 hour and 45 minutes. Figure 4 shows an undamaged blade together with the one that failed. The failures were attributed to a lack of strength in the weld between the airfoil and base.

Figure 3. - Failure of Inconel X airfoil.

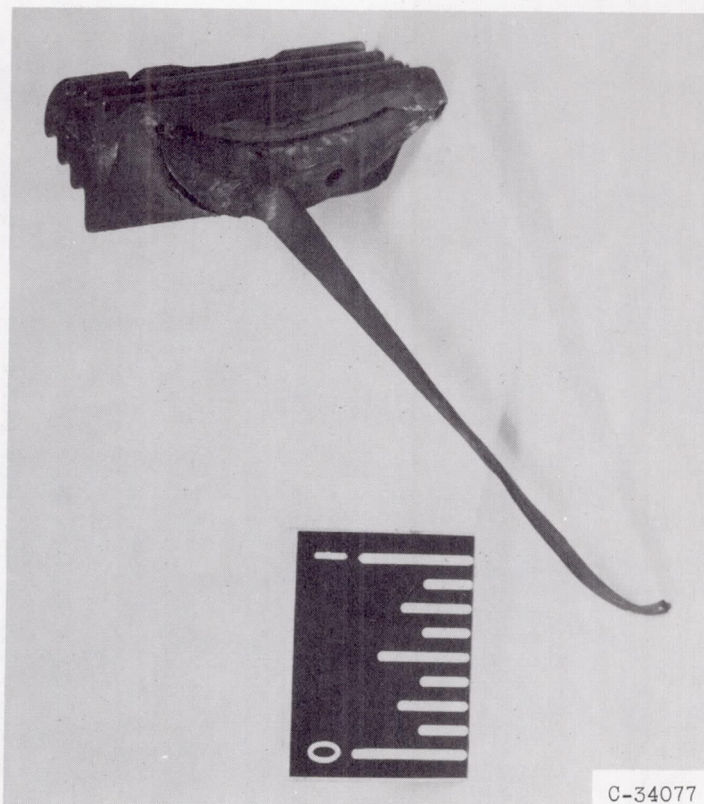
(b) 0.040-Inch wall thickness.

Figure 3. - Failure of Inconel X airfoil.

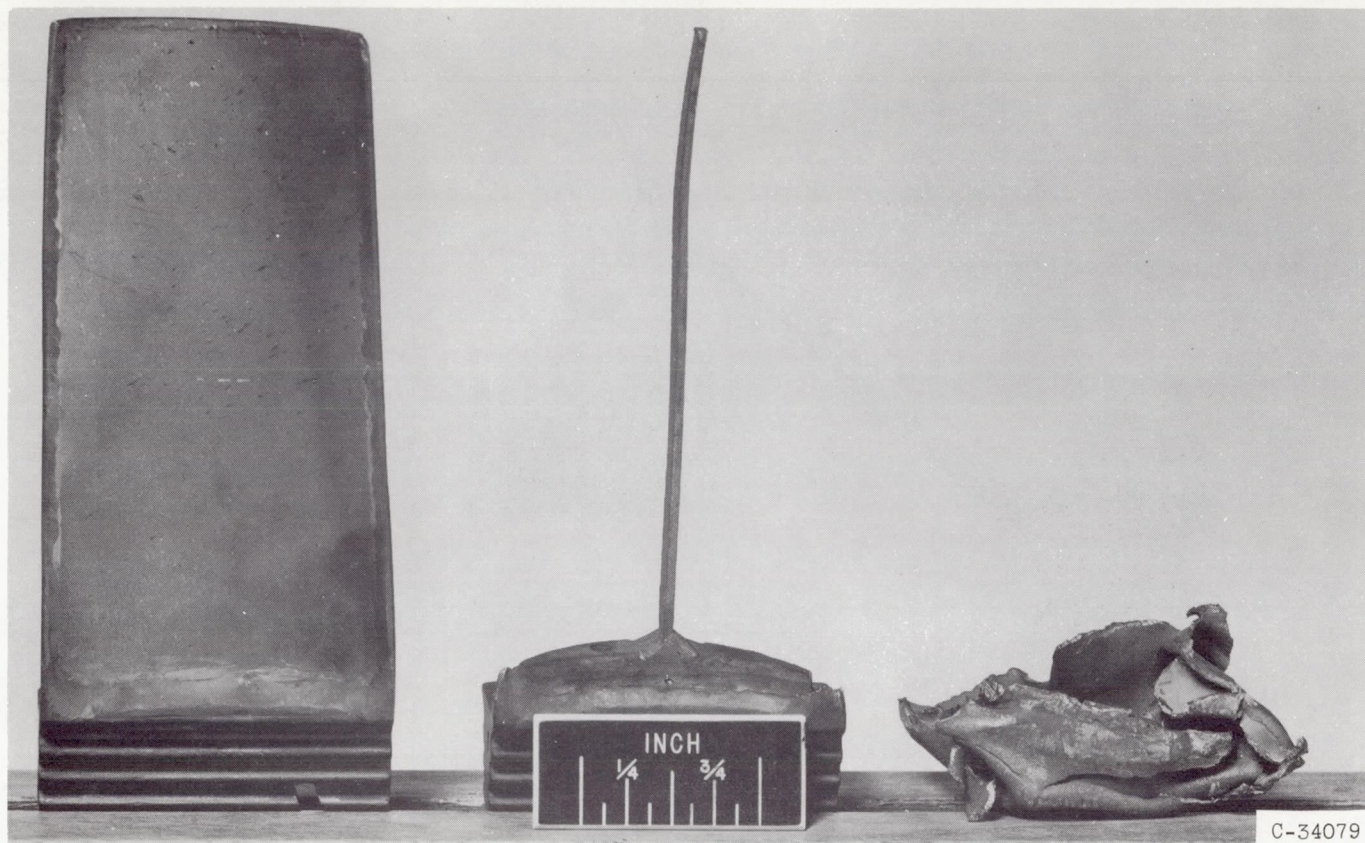
Figure 4. - Inconel X blade (0.040 - 0.020 in. tapered wall) before and after failure due to operation.

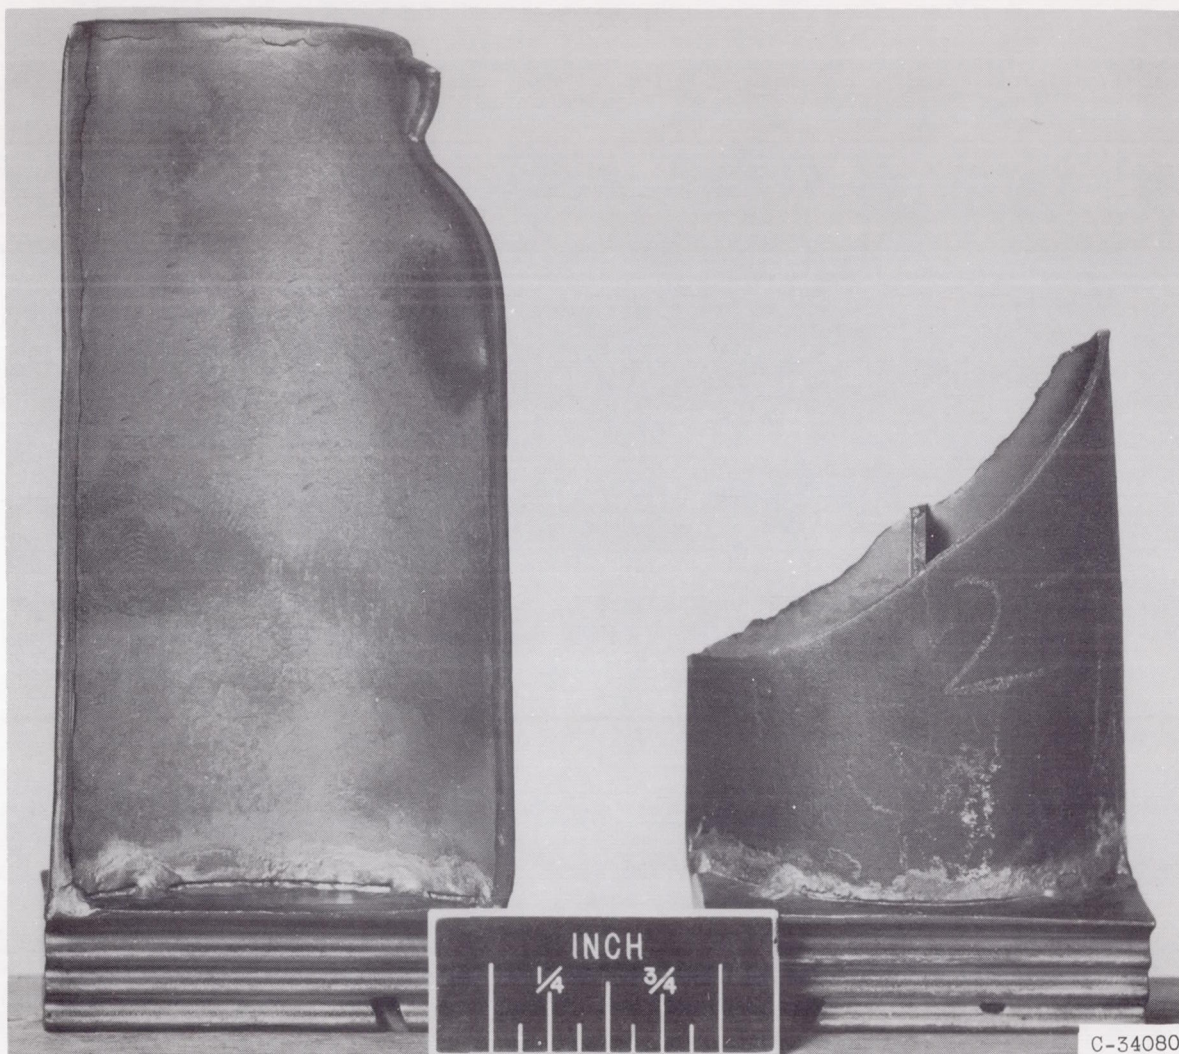
In the initial engine operation of L-605 blades brazed to stub bases, a service life was obtained of 15 hours and 39 minutes. The failure occurred in the central region of the airfoil. Figure 5 shows this blade together with one that had received impact damage.

Figure 5. - Failure of L-605 airfoil (0.030-in. wall thickness) and similar blade with impact damage.

The construction of the blades was altered slightly for the remainder of the investigation. The stub bases were reduced to 0.13 inch in height, and the vibration damper was abandoned. Examination of previous failures indicated that the damper was not operating effectively.
